Region 9 Enforcement Division
75 Hawthorne Street
San Francisco, CA 94105

Inspection Date(s):	March 8 & 9, 2017		
Time:	Entry: 12:30pm (March 8)	Exit: 3:00pm (March 9)	
Media:	Water		
Regulatory Program(s)	Clean Water Act NPDES		
Company Name:	Beta Offshore		
Facility or Site Name:	Platform Elly and Platform Ellen		
Facility/Site Physical Location:	Outer Continental Shelf, Long Beach, CA		
Geographic Coordinates:	33.583537, -118.128567		
Mailing address:	111 W. Ocean Blvd. Suite 1240 Long Beach, CA 90802		
Facility/Site Contact:	Diana Lang	Title: HSE Manager	
	Phone: 562-628-1529	Email: dlang@memorialpp.com	
Facility/Site Identifier:	NPDES Permit CAG280000 / CAF001147 & CAF001148		
NAICS:	211111		
SIC:	1311		
Facility/Site Personnel Participating in Inspection:			
Name	Affiliation	Title	Email
Diana Lang	Beta Offshore	HSE Manager	[HYPERLINK "mailto:dlang@memorialpp.com"]
Christian Zumaran	Beta Offshore	Facilities Engineer	[HYPERLINK "mailto:czumaran@memorialpp.com"]
Jamie Cool	Beta Offshore	Production Manager	[HYPERLINK "mailto:jcool@memorialpp.com"]

SECTION I – INTRODUCTION

Appendix 1 – Photograph Log

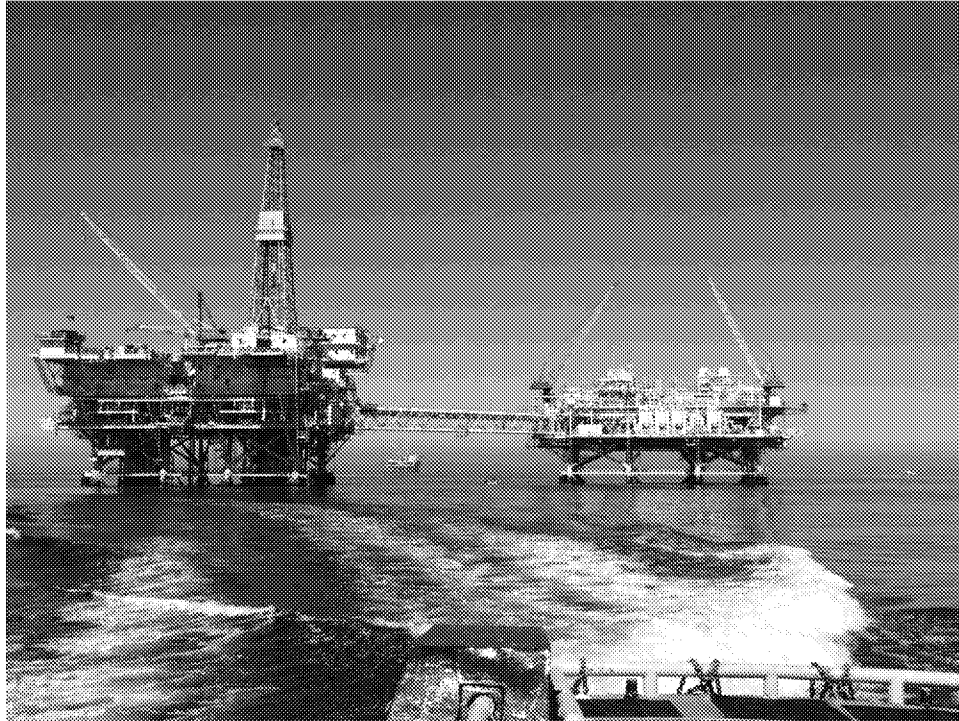
Photo 1: Platform Ellen (left) and Elly (right) are connected by a walkway. Platform Edith (owned and operated by DCOR) is in the background.

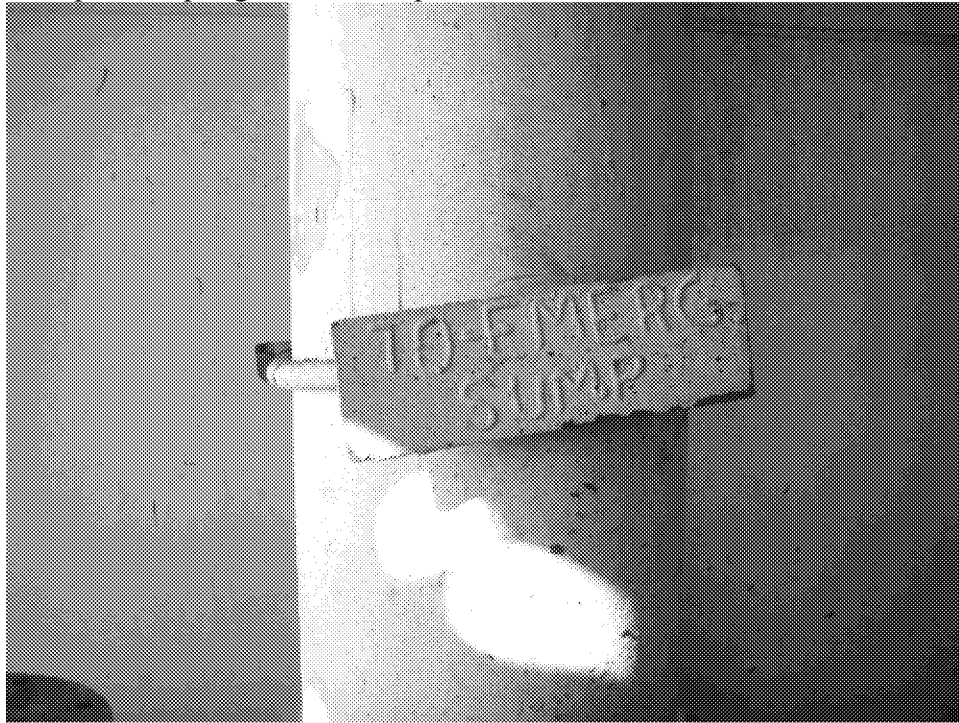
Photo 5: Close up of sign posted on 14" pipe leaving tank S-03 and leading to the open-bottomed Emergency Sump.

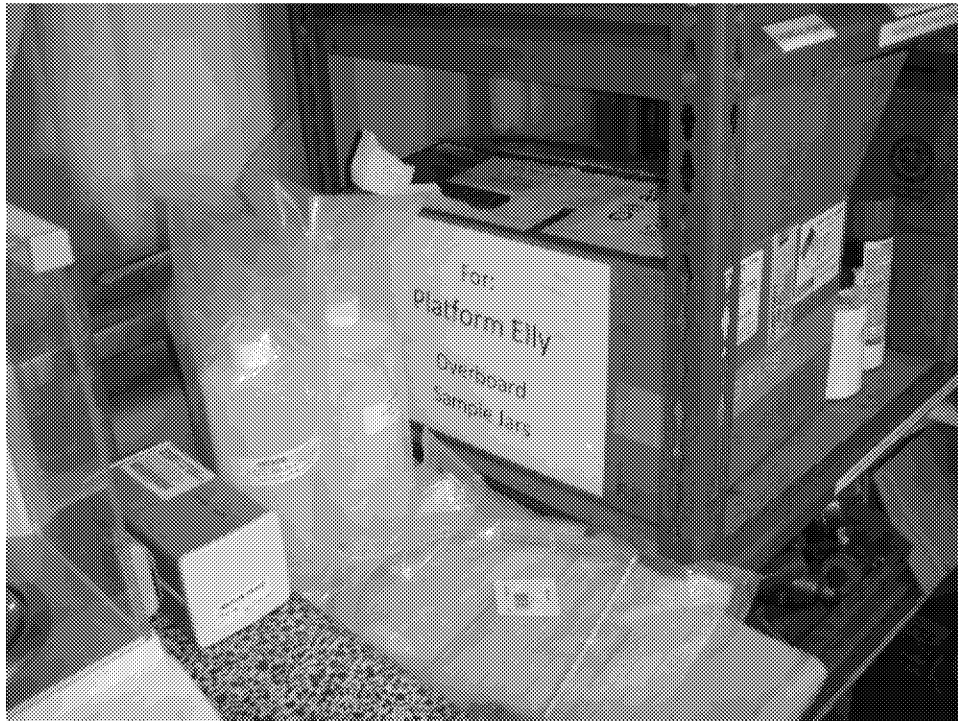
Photo 6: In Laboratory, box of glass amber bottles for oil and grease sampling of discharge 002.

14. We observed glass amber bottles and plastic bottles (for metals) in the laboratory (see Appendix 1, Photo 6).
 15. According to this operator, most discharge events occur between 15 and 20 minutes. He does not recall any event lasting more than one hour.

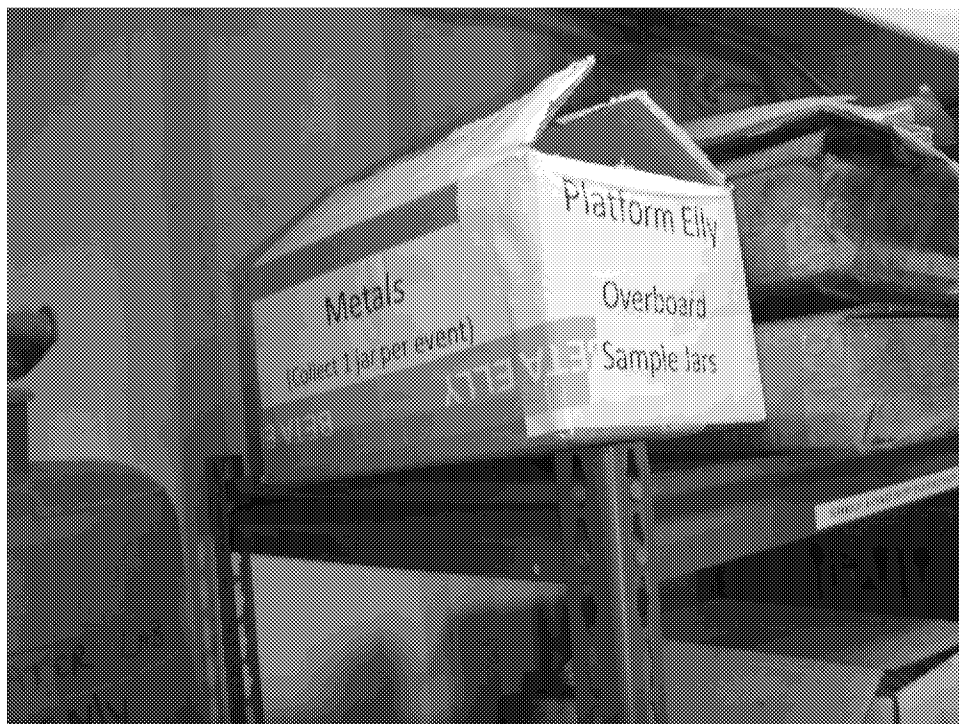
Photo 7: In Laboratory, box of plastic sample jars for metals sampling of discharge 002.

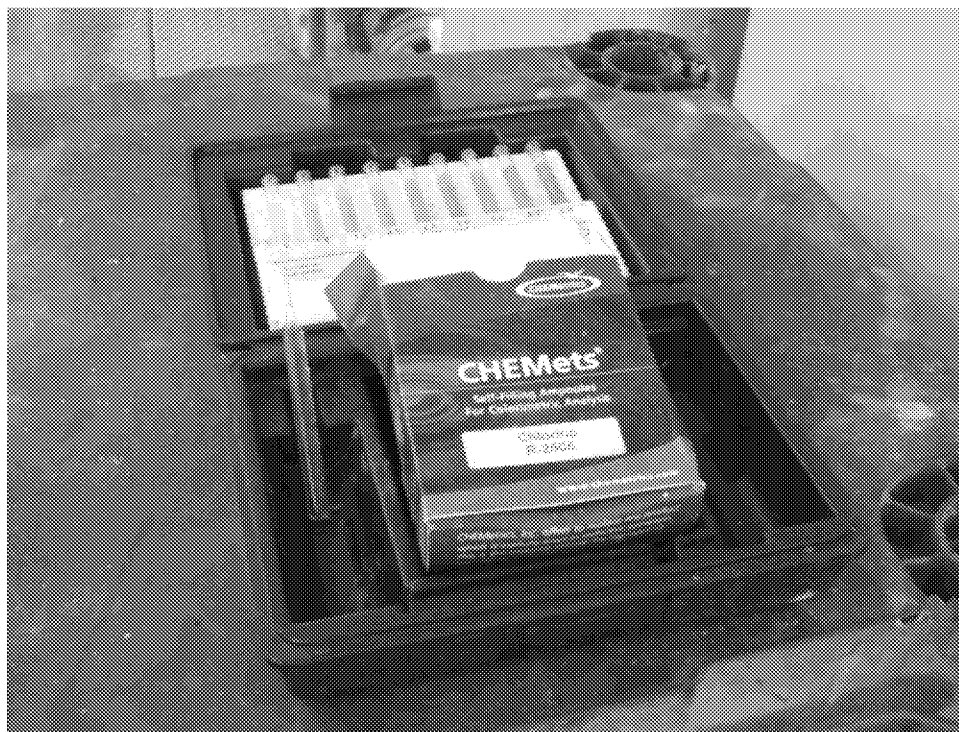
Photo 11: Residual chlorine test kit. Note the ampule with purple fluid on the left—part of the demonstration of how residual chlorine is tested.

40. The residual chlorine is tested daily using CHEMets (see Photo 11). An operator demonstrated how he would fill the glass pipette and compare the color within the pipette to a standard in the box (see Photo 11).
41. The residual chlorine discharged for March 7, 2017 was 3.5 mg/L.
42. There is an offline MSD unit adjacent to MSD unit online.
